# Runaway M60 Machine Gun

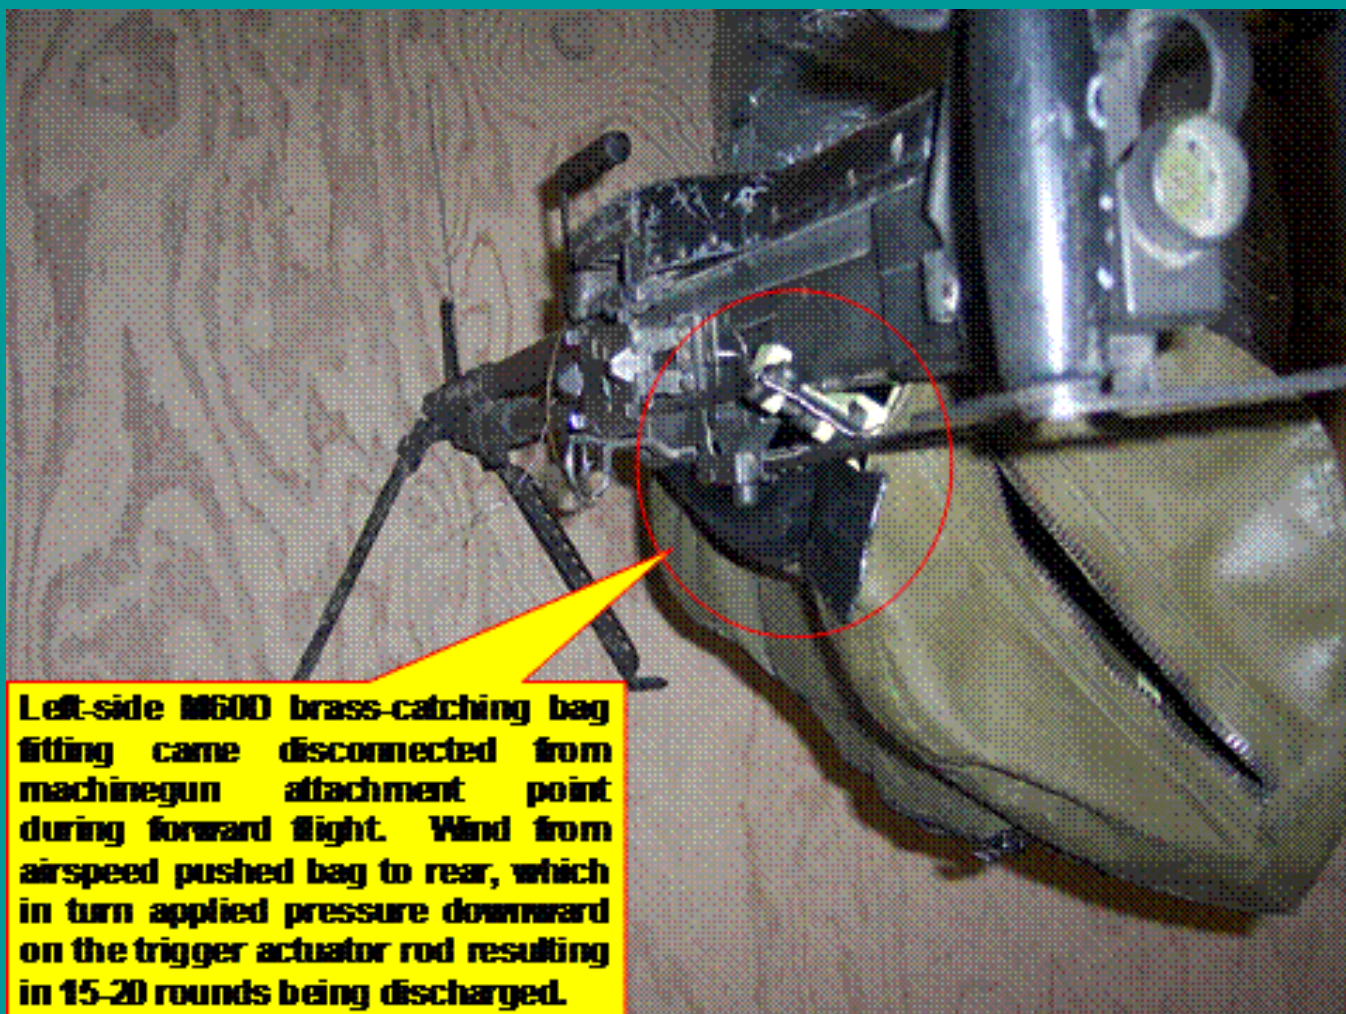
**Left-side M60D brass-catching bag fitting came disconnected from machinegun attachment point during forward flight. Wind from airspeed pushed bag to rear, which in turn applied pressure downward on the trigger actuator rod resulting in 15-20 rounds being discharged.**

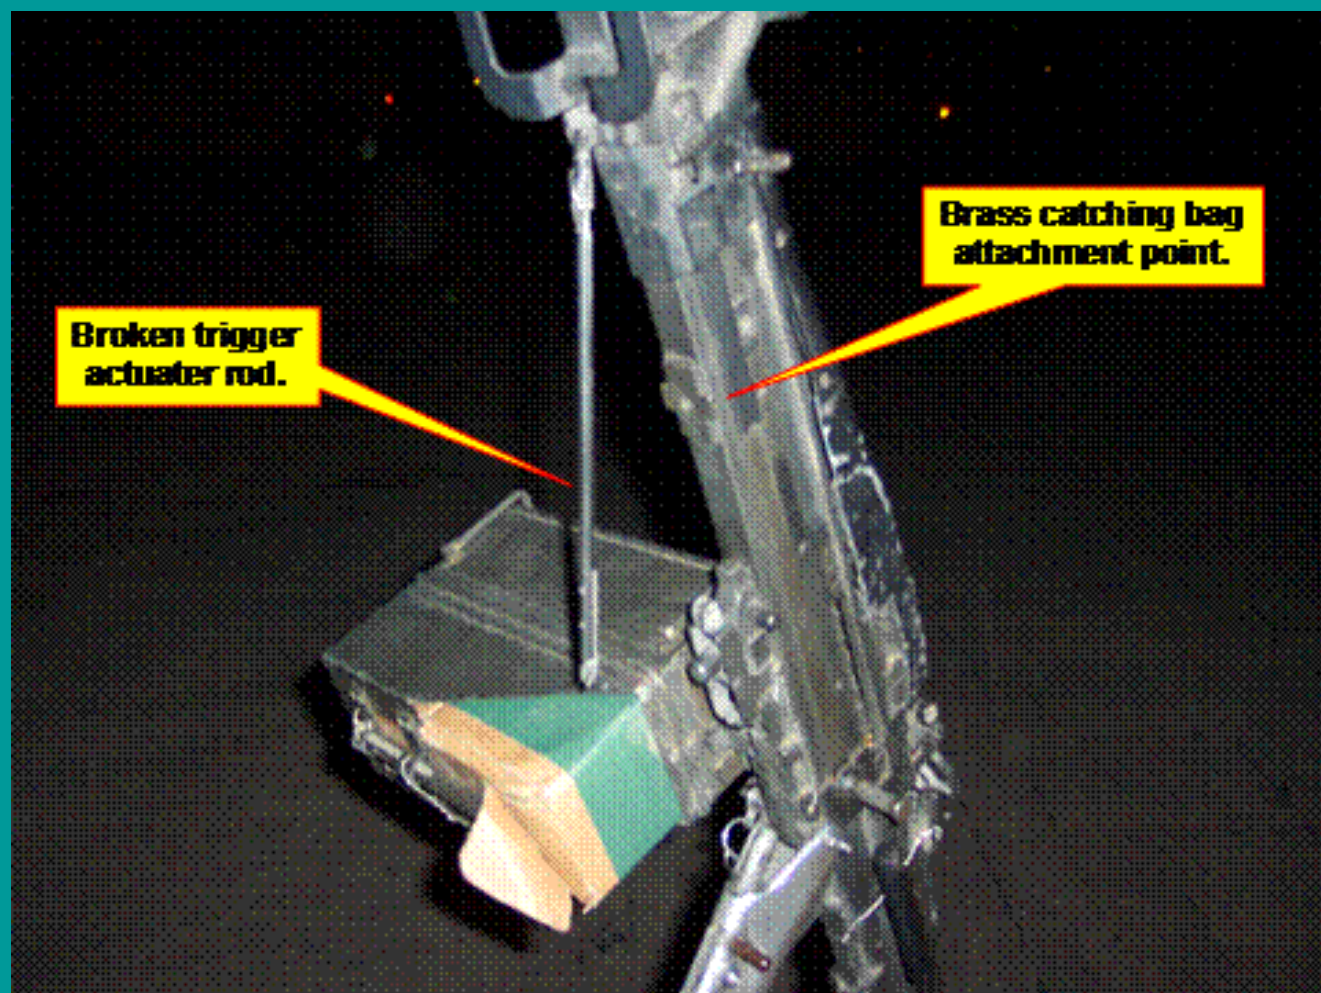
**Broken trigger  
actuator rod.**
